ATTAR TEST REPORT NUMBER: 15/8788.11
Replacement of ATTAR Test Report No. 15/8788.3

Total Pages: 2**WET PENDULUM SLIP RESISTANCE**

Job No: M15/8788

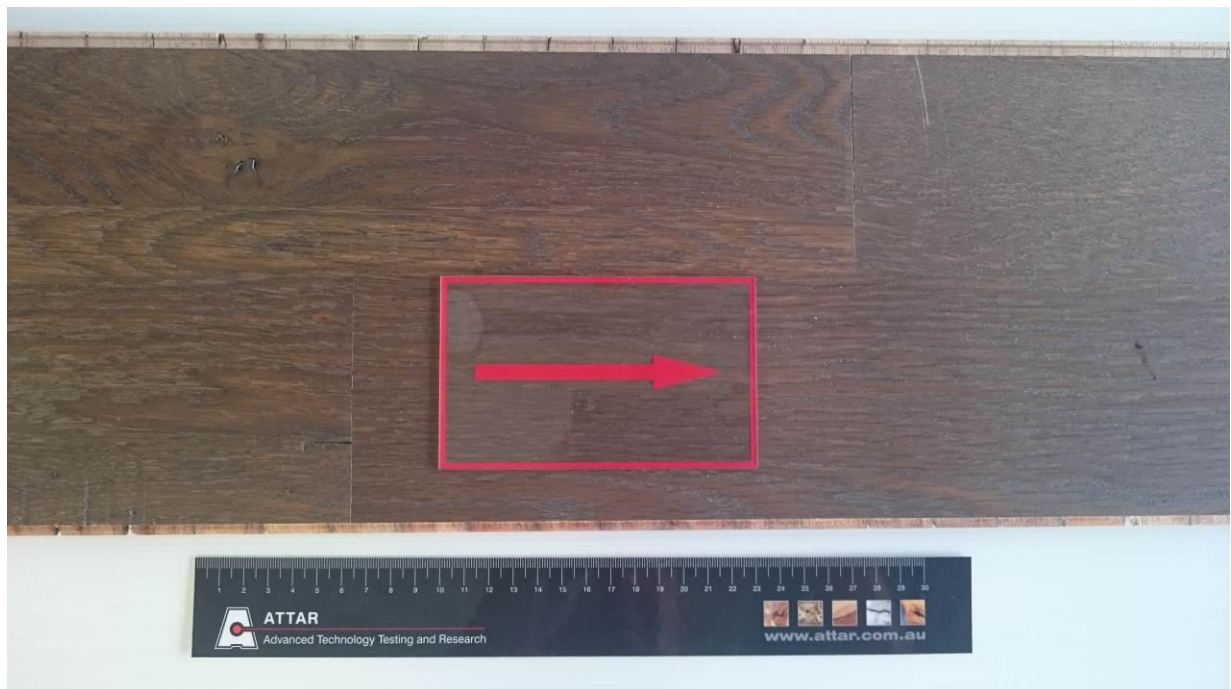
Figure 1: Unilin Laminate wood floor Oiled.
Highlighted area indicates direction of test.

Classification Criteria:	Refer to Classification Criteria, attached as Appendix 1.					
British Pendulum Number	Specimen Number					SRV
	1	2	3	4	5	
	33	27	29	29	29	29
Classification:	P2
